MASCOT IMAGES FROM ASTEROID RYUGU

Japan's Hayabusa2 spacecraft deployed the MASCOT lander to asteroid Ryugu yesterday. Now, MASCOT has returned its 1st image. An international team of engineers and scientists in Germany is standing by.

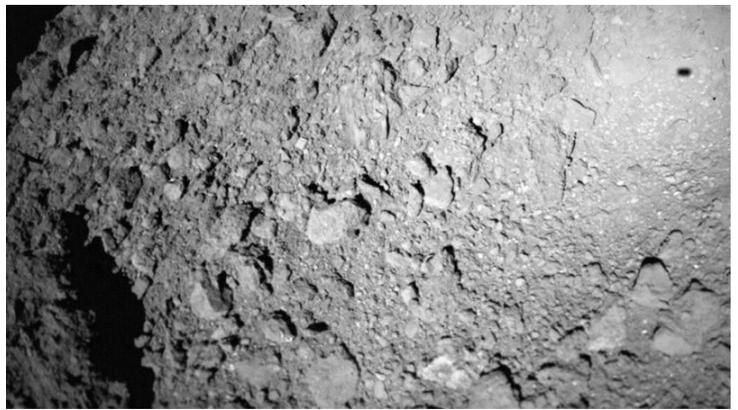
The MASCOT lander captured this image of asteroid Ryugu while descending to the asteroid's surface on October 3, 2018. The lander's shadow is visible in the upper right corner.

The newly released image shows the surface of the tiny asteroid, about 1 km diameter, in great detail, as well as MASCOT's shadow on the top right of the photo. The Japanese Space Agency's Hayabusa2 began its descent towards Ryugu on October 2. MASCOT was ejected at an altitude of 51 metres and descended in free fall – slower than an earthly pedestrian walking – to the asteroid. MASCOT came to rest on the surface approximately 20 minutes after the separation. Although it is basically square and does not have wheels, MASCOT has an internal mechanism allowing it to make a jump in the asteroid's very low gravity to reposition itself if needed.

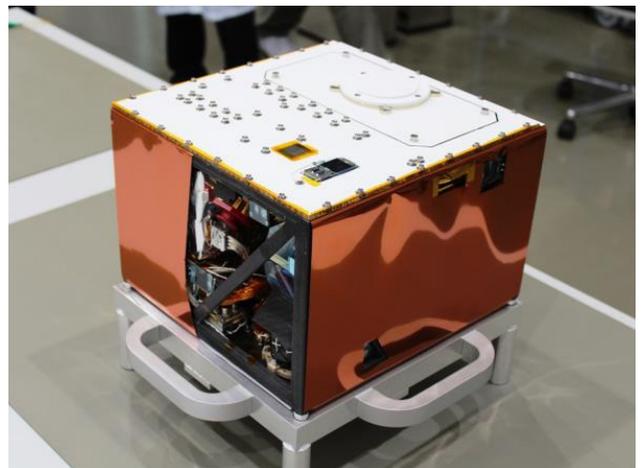
The MASCOT lander before launch.

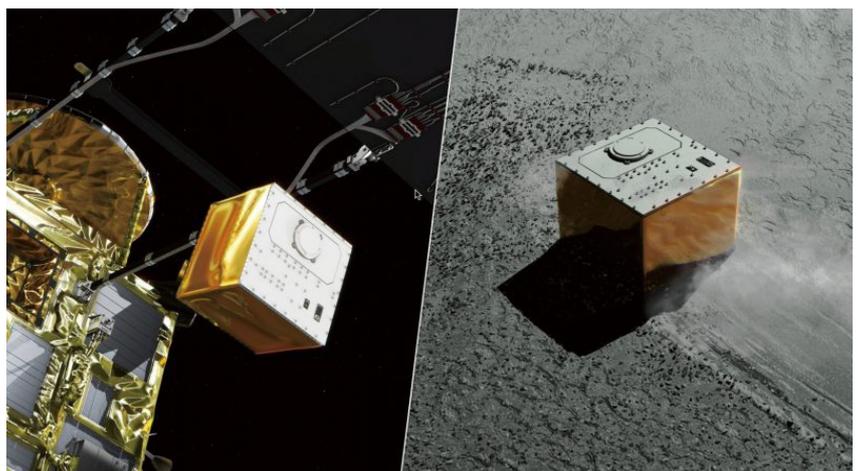
Left: Artist's concept of MASCOT lander separating from Japan's Hayabusa2 mother ship. Right: Artist's concept of MASCOT landing on the surface of the asteroid Ryugu.

The Japanese Space Agency's Hayabusa2 began its descent towards Ryugu on October 2. MASCOT was ejected at an altitude of 51 metres and descended in free fall – slower than an earthly pedestrian walking – to the asteroid. MASCOT came to rest on the surface approximately 20 minutes after the separation. Although it is basically square and does not have wheels, MASCOT has an internal mechanism allowing it to make a jump in the asteroid's very low gravity to reposition itself if needed.
